Zlin Aviation S.R.O.

Safety Alert	N°07	30 October 2012
---------------------	-------------	------------------------

- **Subject:**
Check status of rudder cables.

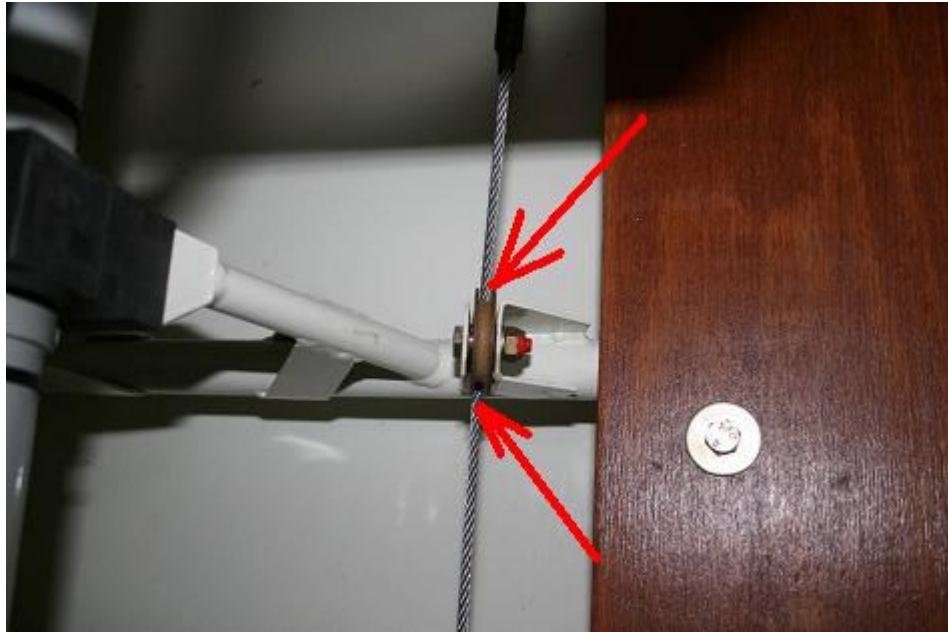
1) Important check points for evaluating the conditions of the cable. Move the rudder or pedals in order to see the cable completely.

- 3) **IMPORTANT:** The Maintenance Manual specifies that the complete check of the conditions of the rudder cables has to be performed in the daily pre flight checks. We strongly encourage to give importance to your pre-flight check and include this point in it every time. Remember, during the check, to apply pressure to the pedals in order to move it and to see the conditions of the cables underneath the pulleys, where they are supposed to suffer more from friction (see pictures). Check also for proper tension and alignment between cable and pulleys.

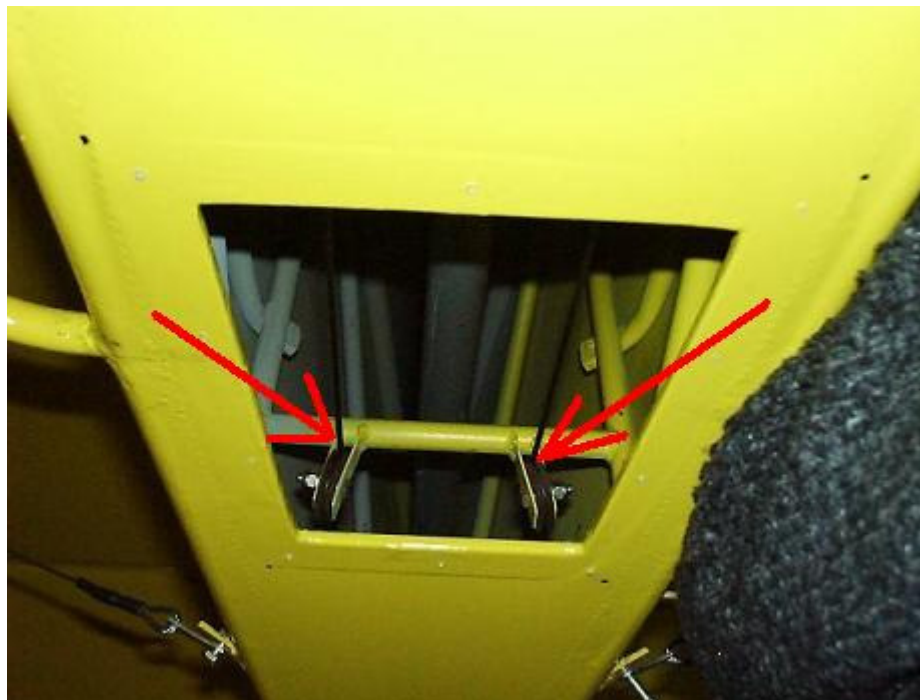
Check also the condition of the rudder cables in the tail section.
